1.1 BAHX – E5-0408 experience higher than designed  $\Delta P$  since commissioning.

1.2  $\Delta P$  kept increasing with increasing plant load and has reached a maximum 13.9 barg in 2010.

- E5 - 0408 / GPP-B

- Duty: 48514 kW
- Type: Aluminium (7 Passes)
- Size: 1782 (m<sup>2</sup>)
- Design Pressure: 81.7 barg
- Design Temperature: 65°C to - 45°C
- Designed Delta P: 1.9 barg
- Construction Material: Aluminum Alloy AA5083, AA3003, Carbon Steel A333 GR 6, A586, A350, Stainless Steel SS304L
-

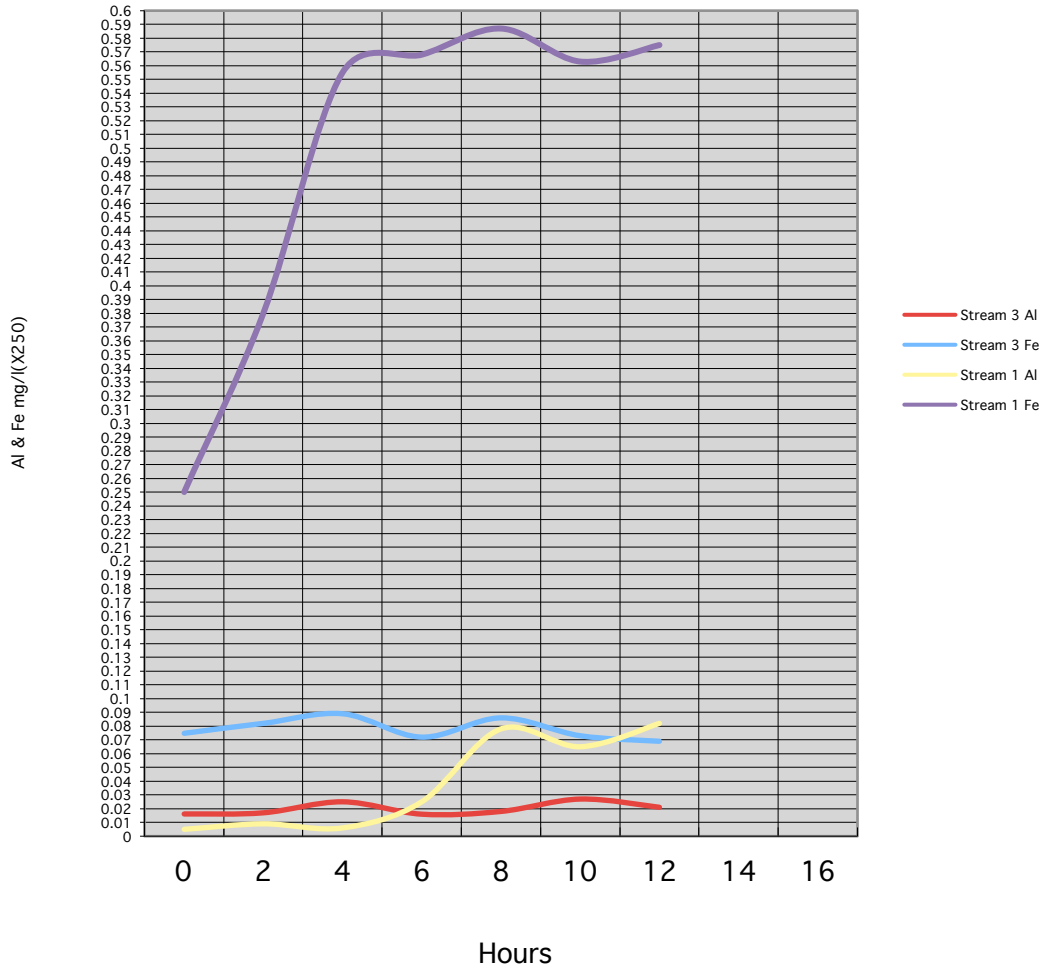
#### 4.2 Removal of Iron Oxide

### 4.4 August 2010 - Results of chemical decontamination using Urea HCl in p - Xylene:

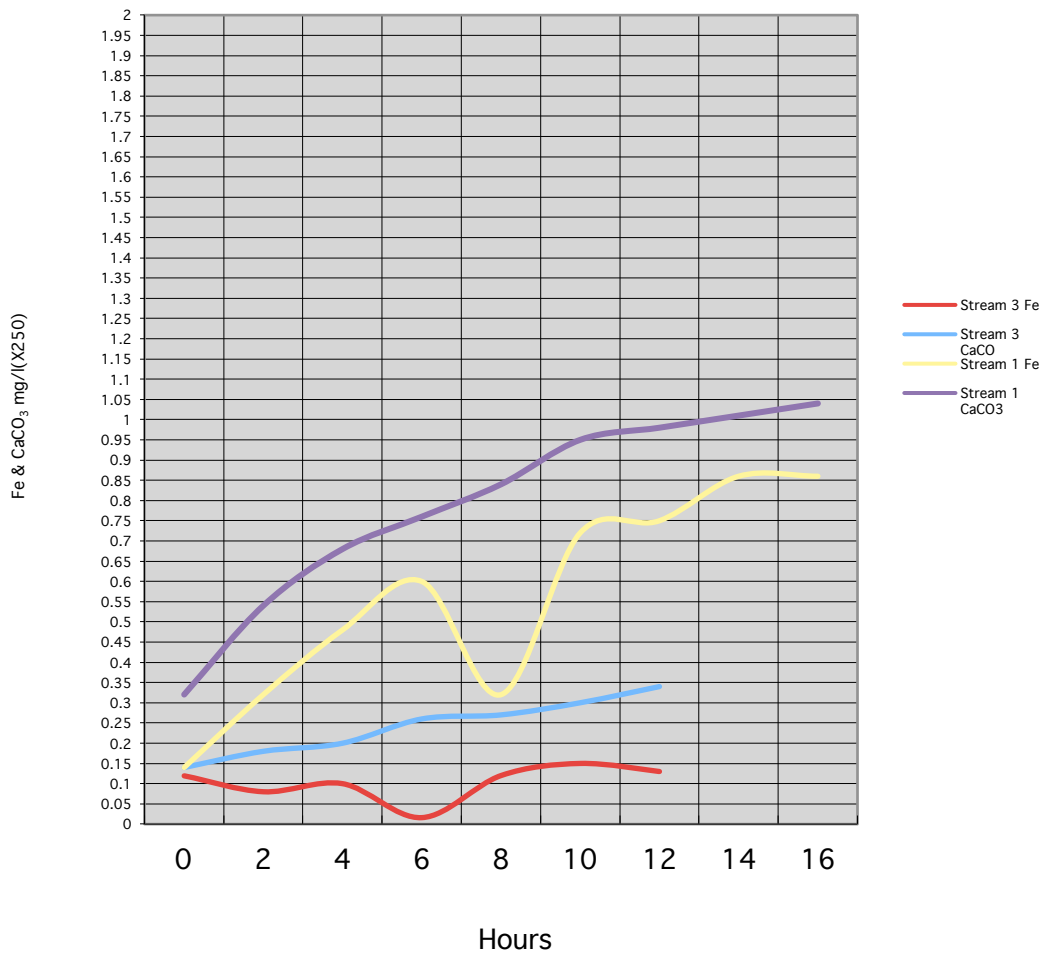
#### 5.2 Removal of Iron Oxide & Calcium Carbonate

### 5.2 November 2010 – Results of chemical decontamination using Thickened Water, BITUSOL and Urea HCl

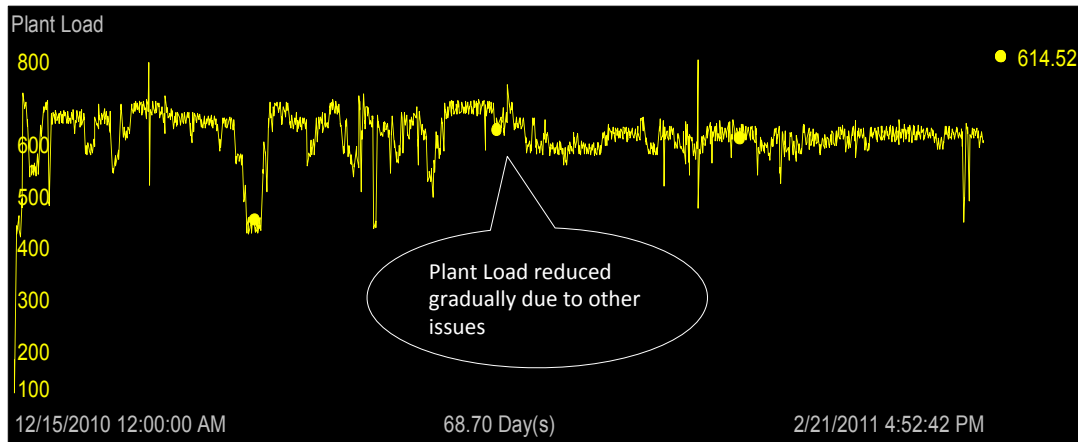
### GPP 5 Plant load after second chemical cleaning@ 14<sup>th</sup> Dec 2010:

- Start of run, the load is 680t/h and gradually maintain low as 614t/h due to business strategy based on availability of feed gas

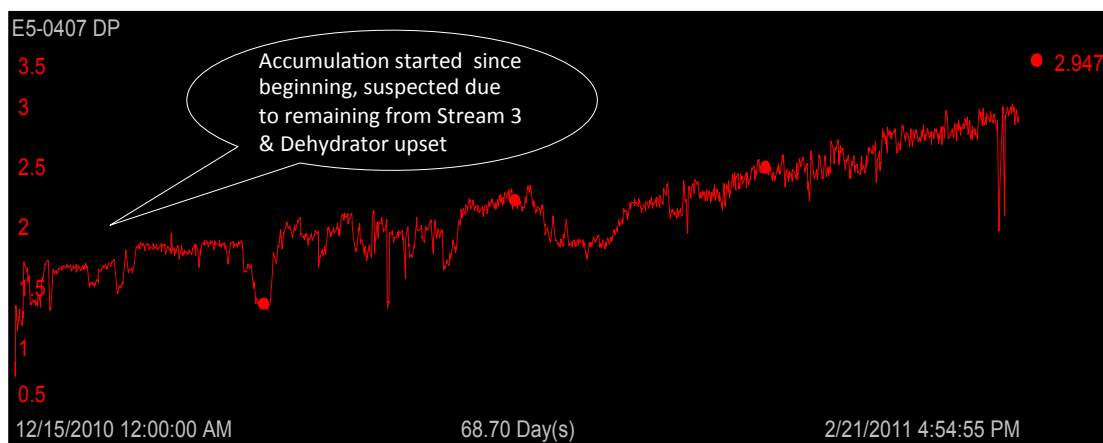
### E5-0407 DP after second chemical cleaning@ 14<sup>th</sup> Dec 2010:

- Start of run, DP across E5-0407 is 1.8 bar. DP has reached 2.9 bar@620t/h in 2 months time.
- DP increasing at start of run suspected some minor left over from Stream 3 of E5-408 has accumulated at E5-0407 strainer.
- Lower DHU performance also promote the accumulation rate to increase

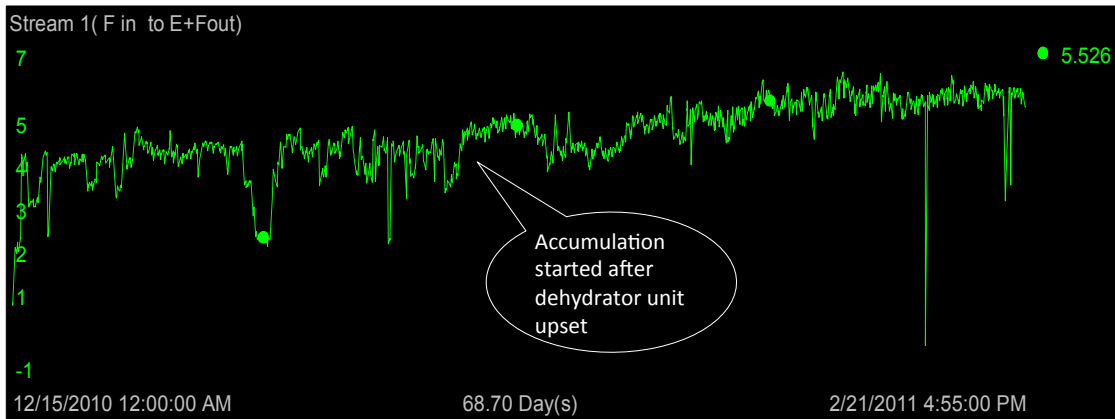
### E5-0408 Stream 1 DP after second chemical cleaning@ 14<sup>th</sup> Dec 2010:

- Start of run, DP is 4.5 bar. DP has reached 5.5 bar@620t/h in 2 months time.
- Accumulation of DP is suspected due to E5-0407 DP increased.
