## Safe CIP removal of FeS-fouling from PHEs in Amine systems safely with great savings.

Case file

## Case 1 - Site Safe CIP Cleaning of AX30-HA Interchanger at Canlin Energy, Canada

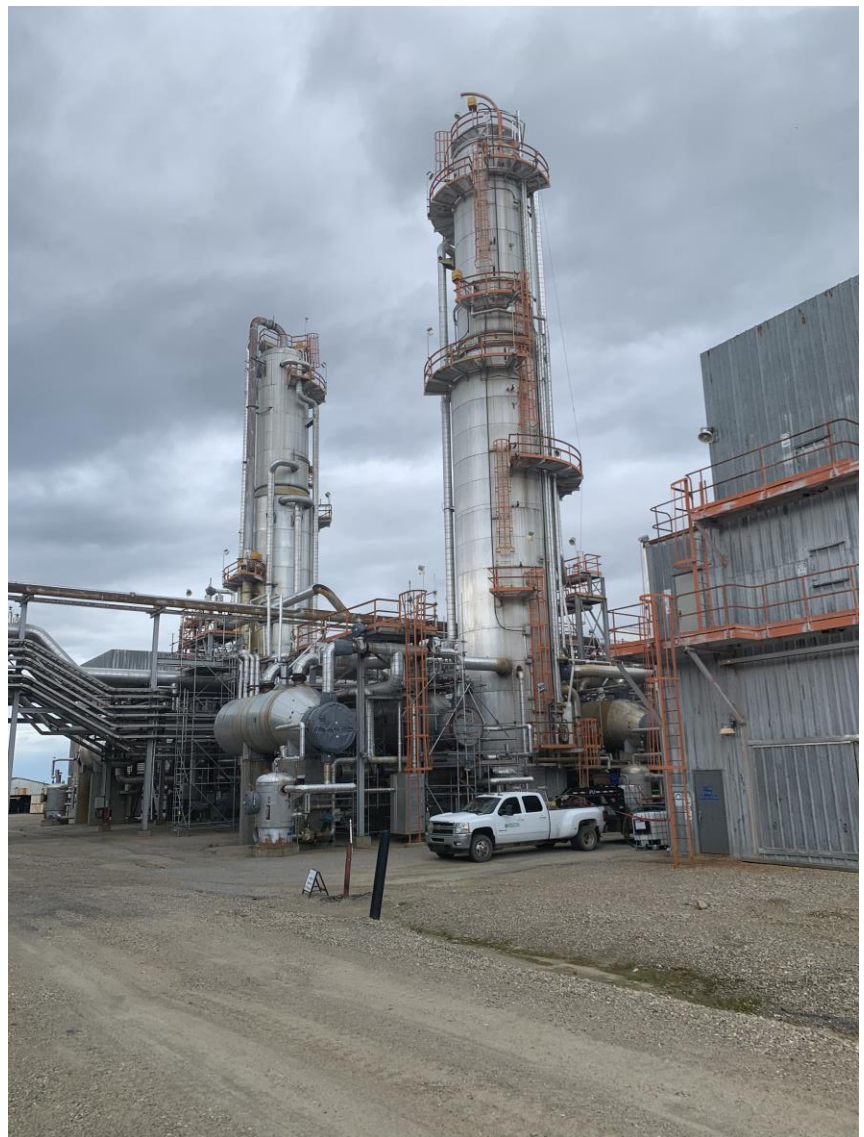
At several locations Alfa Laval Service Center in Middle East and Edmonton and at customer site in Canada, plate different heat exchangers one CPK 75/500, two MA30-W, a T20-MFG and an AX30HA used in amine gas treatment were cleaned with the newly developed **Safe CIP** method. With ordinary cleaning, iron sulfides deposit within the PHE and cannot be removed with ordinary CIP techniques without generating highly toxic hydrogen sulfide (H<sub>2</sub>S). As a part of the project **Safe CIP**, trials and customer site cleanings were performed with our collaboration partner CTI (Concept Technology Inc., Canada). A high-competence two-step process using new CIP chemicals introduced within the AlfaLaval range that effectively clean the plates without generation of H<sub>2</sub>S.

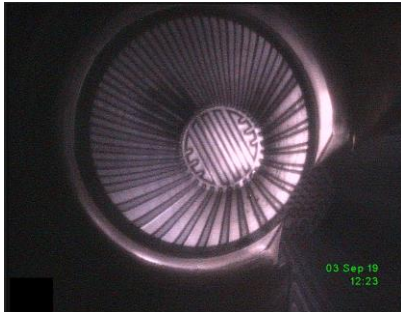
Lean Inlet after Safe CIP cleaning

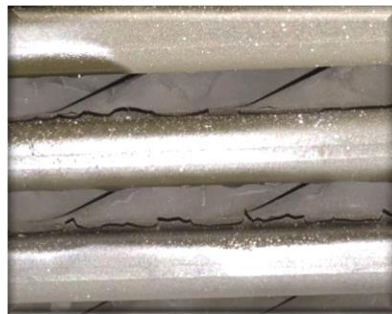
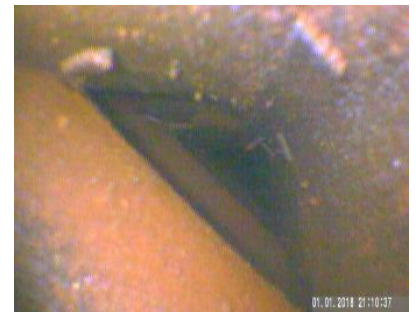
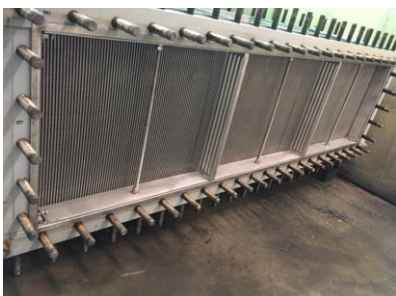
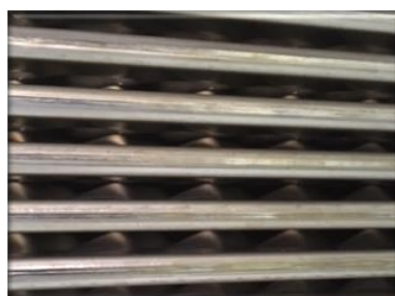
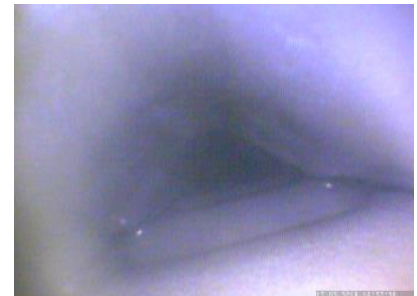
A full size CP57/500 interchanger from a main Middle East O&G producer was successfully cleaned on both Rich and Lean side Without any generation of H<sub>2</sub>S.

Top pictures showing out- and inside of before (top) and after (bottom) Safe CIP cleaning.

Levels were continuously measured as well as monitoring the progress of the cleaning to ensure safe end point determination.

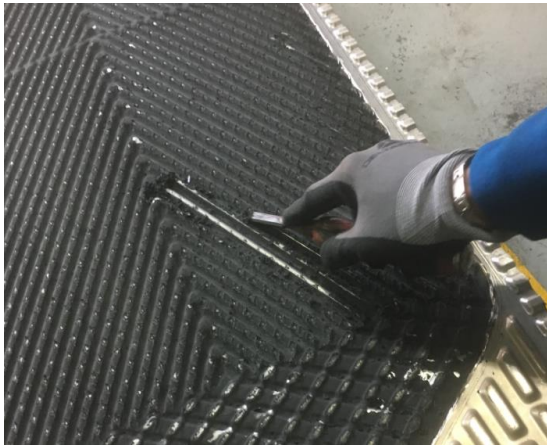
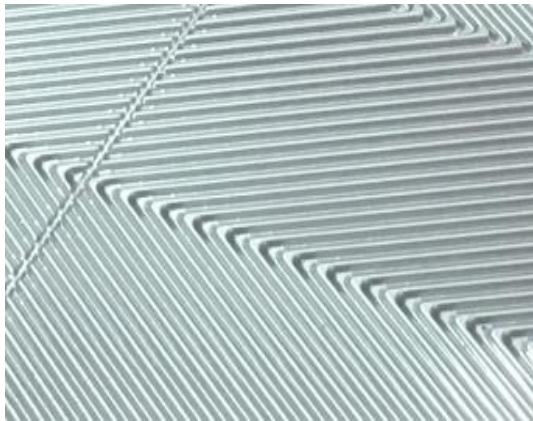
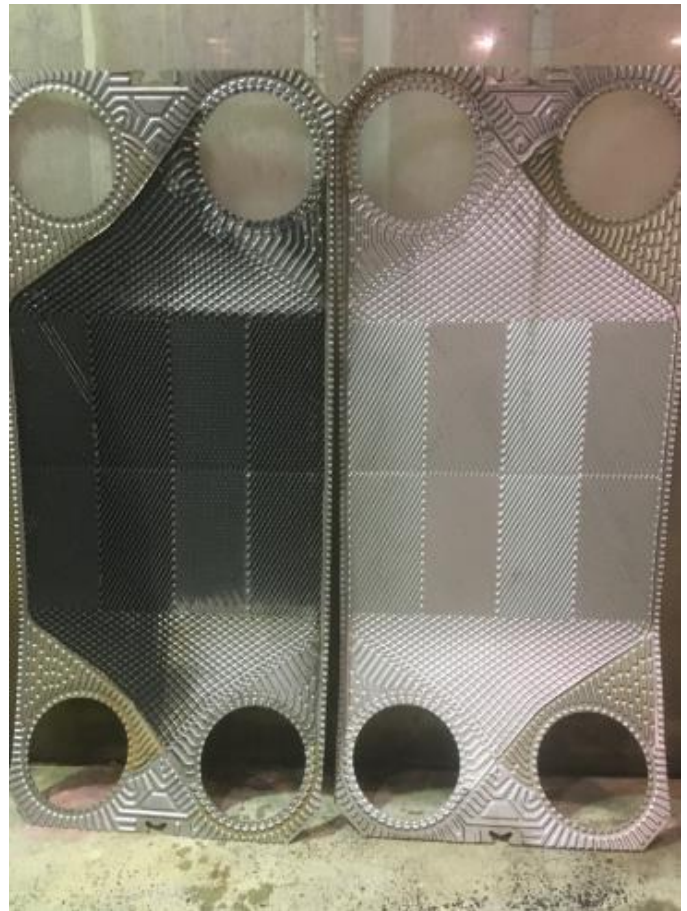
Pictures of opened cassettes of a MA30-W before and after Safe CIP cleaning.

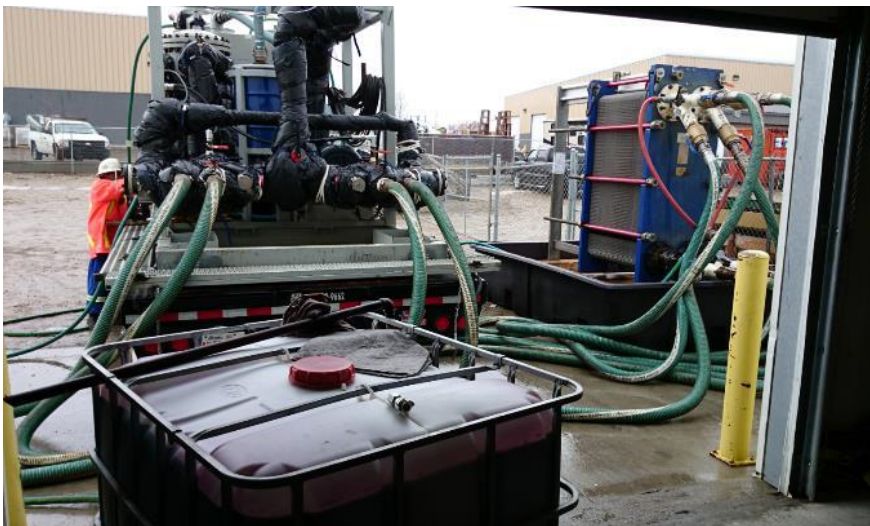
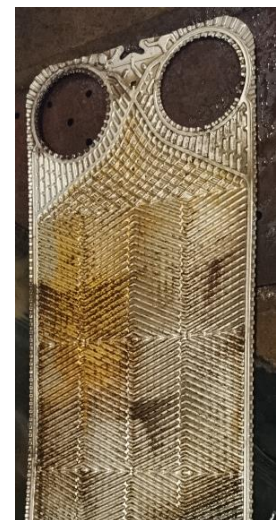
Hydrocarbons burned into the plate during operation process caused the discoloration. FeS-fouling is removed – without any H<sub>2</sub>S generated.
